Emergency Stabilization & Rehabilitation Plan

# KNP Complex

Sequoia and Kings Canyon National Parks, CA

<b>Fire Name</b>	KNP Complex
<b>Fire Number</b>	CA-KNP-000124
<b>Fire Code</b>	N9UH
<b>Detection Date/Cause</b>	9/10/2021 /Lightning
<b>Date Contained</b>	N/A
<b>Acres</b>	Total Acres = 88,307 (as of 11/1/2021) Total Acres burned in SEKI = 78,675

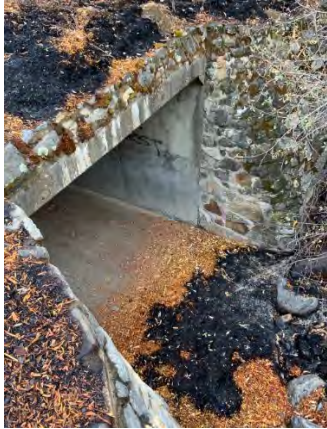
<p>Alder Creek at ~MP 1.3 near Park HQ has a 48" culvert set under deep road fill</p>	<p>Elk Creek near MP 4 has an 8x10 foot box culvert draining this stream.</p>	<p>The highway crosses the Marble Fork of the Kaweah River at MP 4 on a substantial bridge</p>

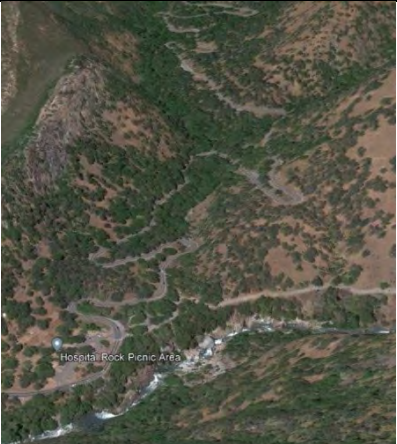
<p>Un-named stream near MP 6 has two 48" culverts</p>	<p>The hydroelectric intake infrastructure has and will continue to accumulate debris</p>	<p>There are several road crossings of an un-named drainage near Hospital Rock and the highway switchbacks (including MP 7)</p>

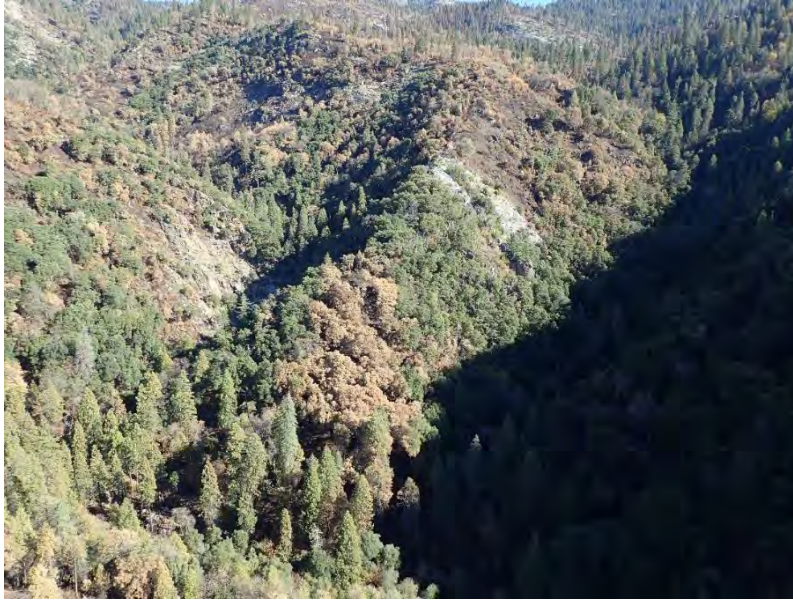
Nevertheless, elevated water discharges and sediment deposition may occur within the cave during storms, potentially impacting the trail and other infrastructure.

*View to the northeast showing the confluence of Yucca Creek (left) and Cascade Creek (right). Crystal Cave occupies the light gray marble band in the center of the photo. A portion of Yucca Creek sinks into this marble and flows through the cave, perpendicular to the ridge separating the watersheds, and emerges below the main cave entrance to join Cascade Creek.*

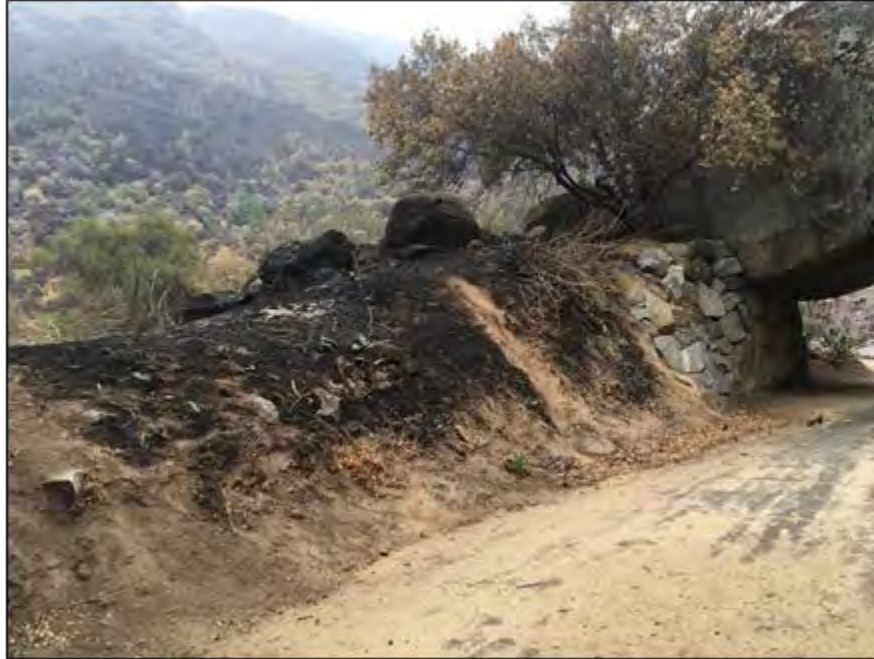
Tunnel Rock (above) is a popular stop for visitors, who use social trails to climb the slopes at either end of the rock that forms the “tunnel”. Eroded areas around the rock were planted to help slow erosion that was threatening the rock’s stability. The plantings were killed by the KNP Fires, exposing the area to renewed social trailing and erosion.

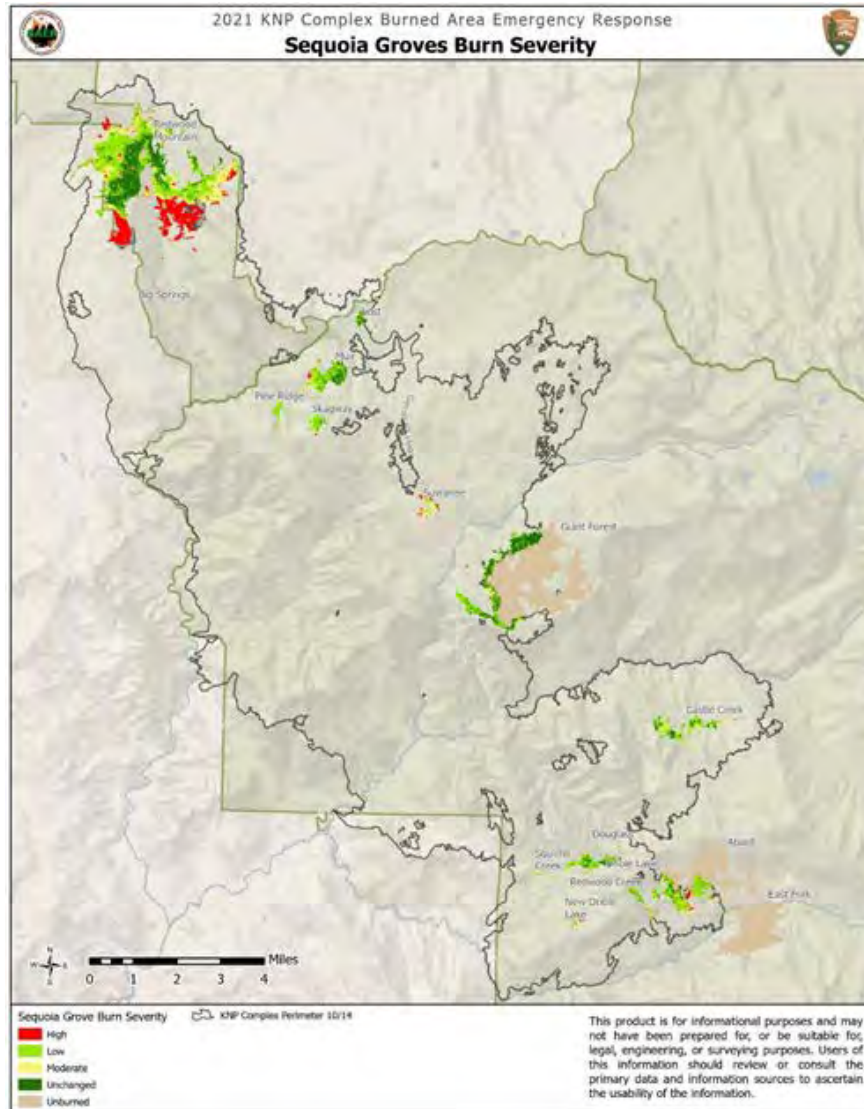
**Figure 9.** Map of groves with burn severity, correlating roughly with loss of canopy.

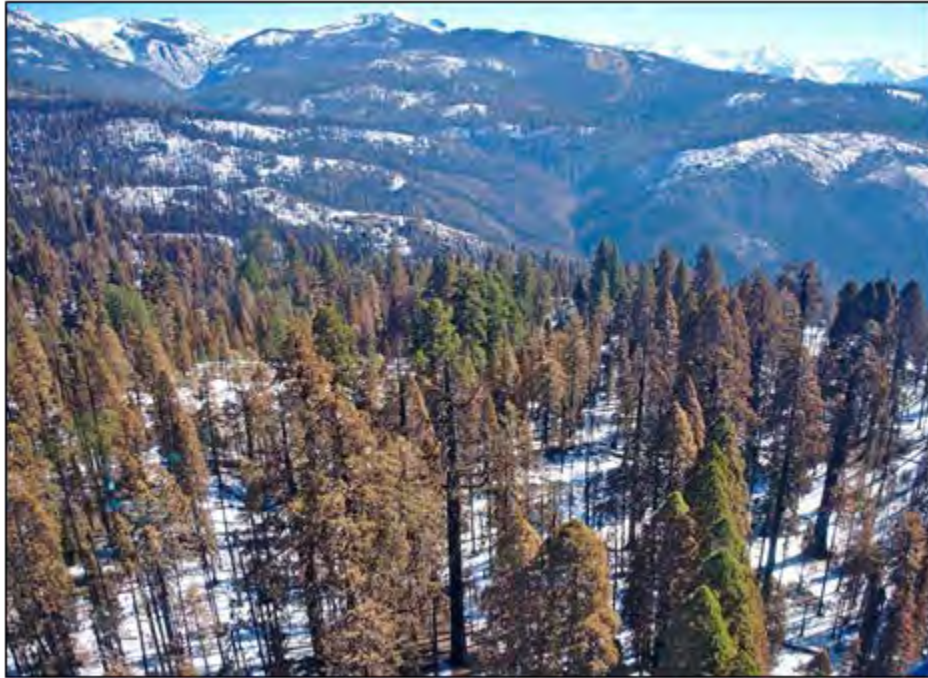
Redwood Mountain Grove had the most substantial acreage impacted by high severity fire (Figure 10a, 10b) followed by Atwell and Suwanee. In the areas in which the Atwell Grove burned severely, the forest was mostly second growth. Reconnaissance via helicopter over the Suwannee Grove indicated that the areas classified as moderate severity were underpredicted in the severity map, potentially resulting in more mortality than expected (Figure 11).

**Figure 11.** Suwanee Grove. View of high and moderate severity across the grove from 10/27/2021.

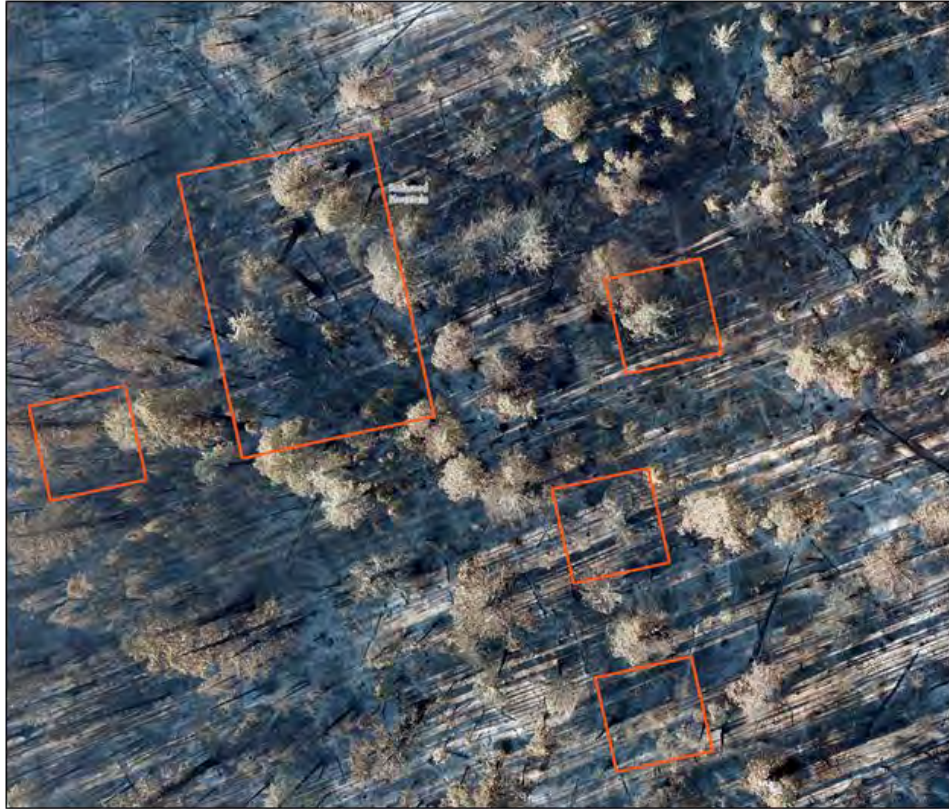
**Figure 13.** Ortho-rectified drone imagery of small moderate severity patches within the large high severity patch of Redwood Mountain Grove. Because surviving trees in these patches could be limited, the acreage calculation for distance to live tree excluded these for the regeneration analysis (Paul Hardwick, personal communication). Orange squares are classified as moderate severity in RAVG.

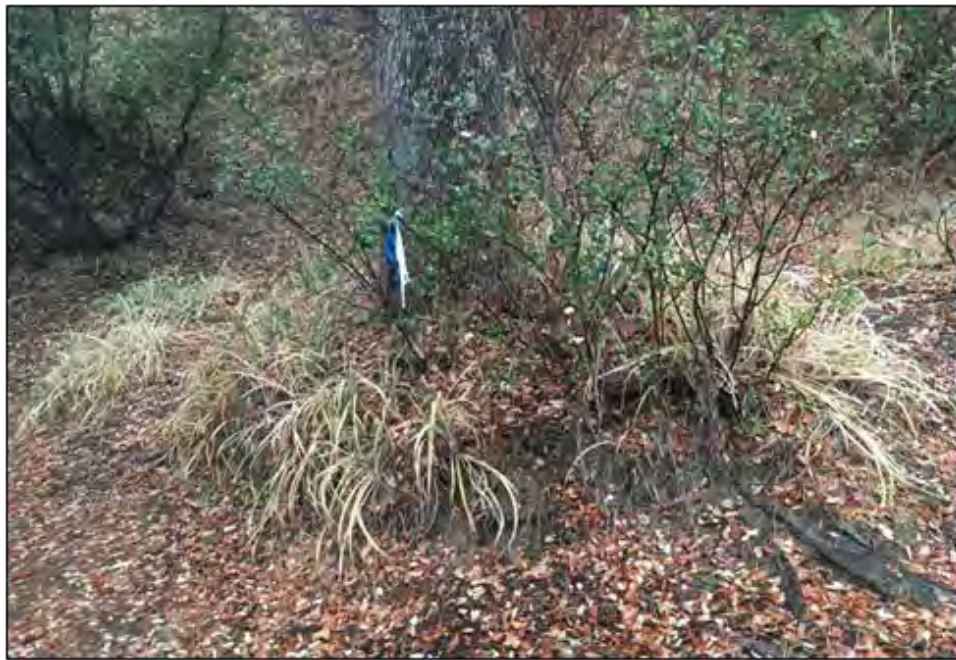
Limited time in the field meant that BAER staff were able to check fire effects on only a few roadside populations of two rare plant species: mouse buckwheat (*Eriogonum nudum* var. *murinum*) and Munz's iris (*Iris munzii*). We found that a roadside population of mouse buckwheat lost approximately 20 individuals to either direct fire effects or from being buried under soil sliding from burned slopes above (Figure 14). This population is the type locality for this taxon and therefore has significant scientific value. Conversely, a brief survey along Shepherd's Saddle road showed no impacts to roadside populations of Munz's iris from bulldozers working to reinforce the road as a fireline (Figure 15).

**Figure 15.** Munz's iris on Shepherd's Saddle road. Heavy equipment reinforced this road as a potential fuel break but avoided impacting this rare plant thanks to READ flagging.

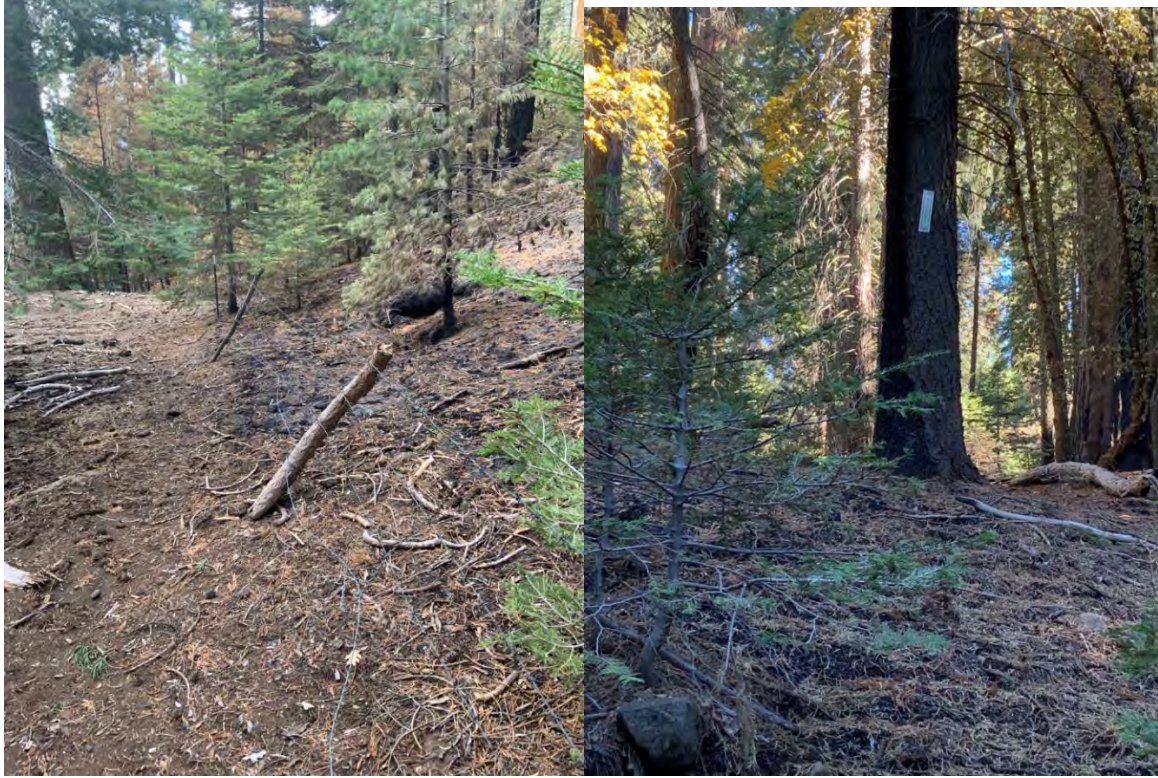
Figure 1. Fencing and Boundary Signs at Redwood Canyon

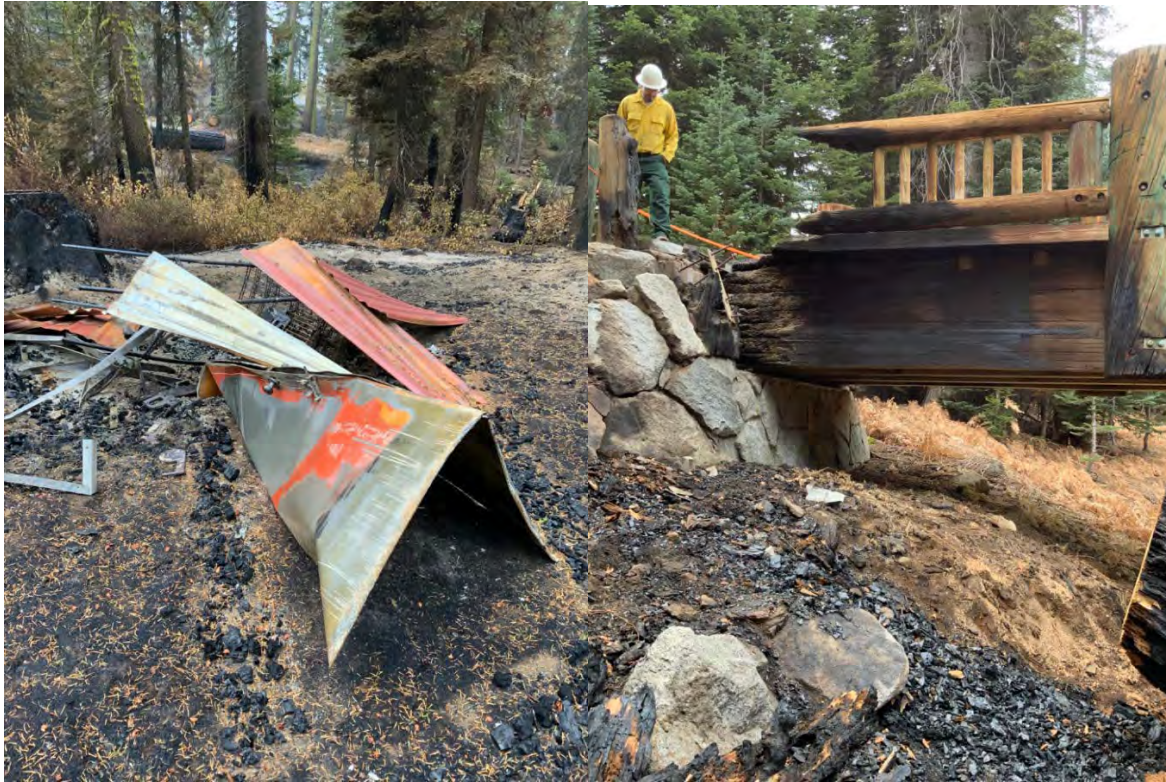
Figure 2. Shooting Range Building and Wuksachi Bridge

33. Replace the 6 x 8 shed at the shooting range
34. Replace the communications equipment at the Milk Ranch communication site
35. Repair the bridge at Wuksachi Lodge

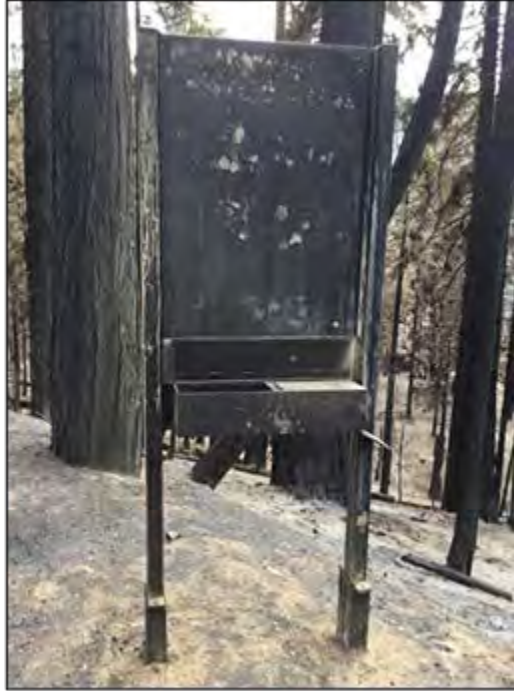
Wilderness Permit Station on Mineral King Road

3. The KNP Complex has destroyed a number of road and regulatory signs throughout the Park, particularly along the Generals Highway. A wilderness permit station was destroyed along the Mineral King Road.
4. Burned terrain may produce hazards on roads and trails (rockfall, flash floods, mudslides, roadway debris, falling trees, etc.). The potential for these hazards will need to be communicated to the public.
5. Sections of Park roads and trails may need to be periodically closed to prevent public exposure to post-fire hazards.
6. Burned vegetation and consumed logs may expose sensitive natural and cultural resources and change visitor use patterns via the creation of new social trails

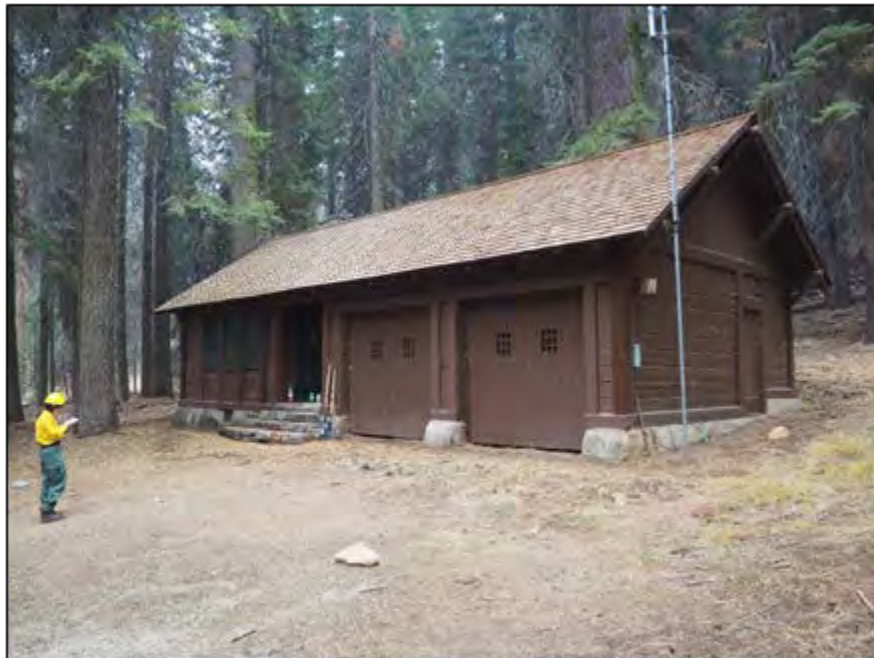
The properties were threatened by the fire from the west and south and a fire break was created to help protect the structures and surrounding property. The site currently does not show any signs of fire damage and it appears that fire did not cross the Generals Highway from the south. Trees are in direct contact with the Dormitory and there is branch damage to an eave section of the Ranger Station, but these conditions were not caused by the fire or any fireactivity. *(See Photos 9 & 10)*

*Photo 10 Cabin Creek Dormitory. View looking southwest.*

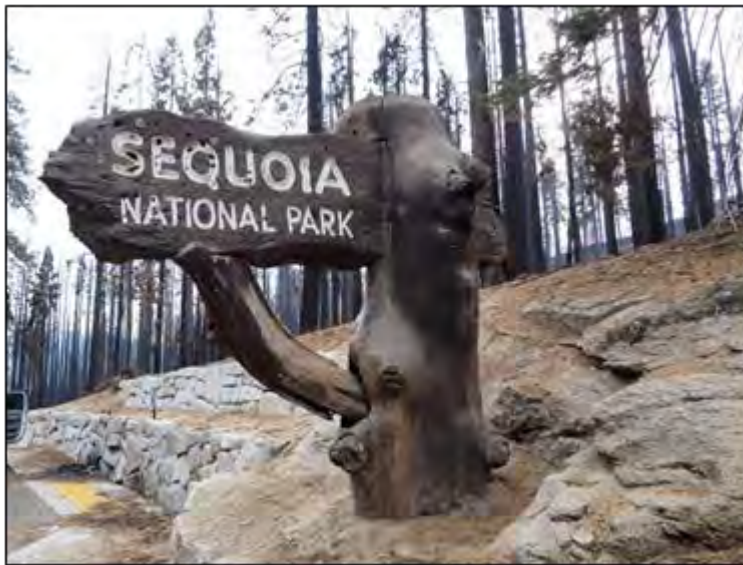
**Sequoia National Park North Entrance Sign** – The Sequoia North Entrance Sign was constructed in the 1930s during the CCC era. It is the most iconic sign located in Sequoia National Park and is an important feature of the Generals Highway Cultural Landscape at the border of Sequoia National Forest along the Generals Highway. The sign was located within the fire perimeter and evidence of fire activity can be found within 40' of the sign. The sign is not painted and shows weather effects due to age and exposure, but there is no specific evidence of fire or suppression effects on the surface or at its base. Hazard trees are in proximity to the sign to the west and will need to be addressed to reduce further threats to the sign's integrity. (See Photo 11)

Photo 11 Sequoia National Park North Entrance Sign. View looking south.

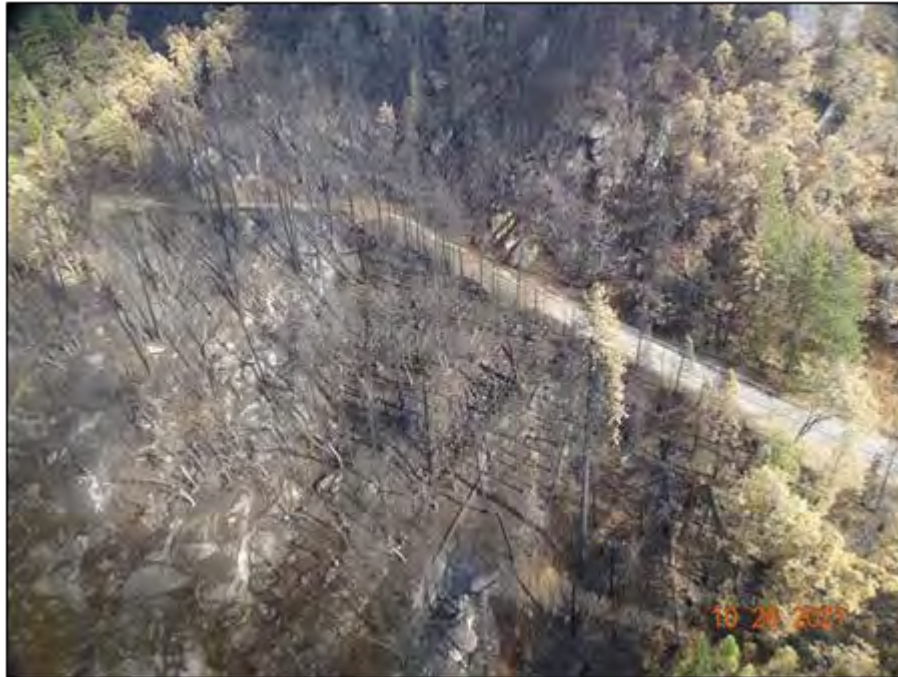
The Generals Highway is the major artery through Sequoia National Park and into Kings Canyon National Park along the western slope of the Sierra Nevada. It extends approximately 32 miles and is a feat of engineering and a scenic highway that contains many distinctive rustic masonry elements built by the CCC. The Generals Highway Historic District is significant under Criteria A and C in the areas of Transportation, Entertainment/Recreation, Engineering, Landscape Architecture, and Social History. The period of significance for the Generals Highway Historic District is 1921-1935. Without a historic landscape architect, the BAER team was unable to confirm the condition of many features of the Generals Highway Historic District. It contains a

*Photo 12 Generals Highway Historic District. View looking down from helicopter.*

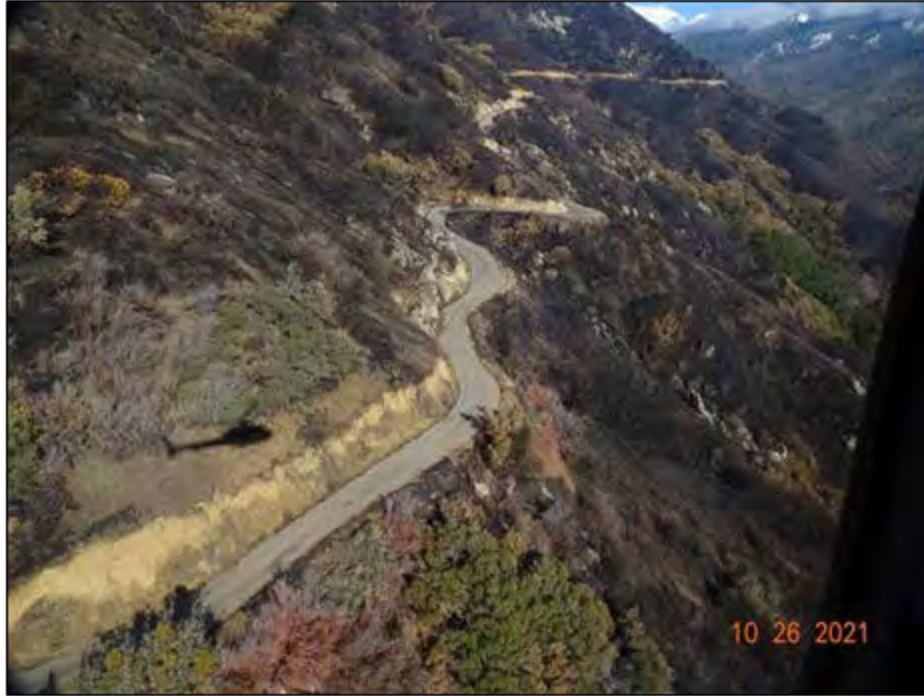
Due to post-fire erosion conditions, the Mineral King Road was impassible, and helicopter reconnaissance indicated there were several mudslides impacting the roads. The debris flow model generated for the incident showed many areas of the road that are predicted to continue to see debris flow. Without a historic landscape architect, the BAER team was unable to confirm the condition of many features of the Mineral King Road Historic District.

*Photo 13 Mineral King Road. View looking northwest from helicopter.*

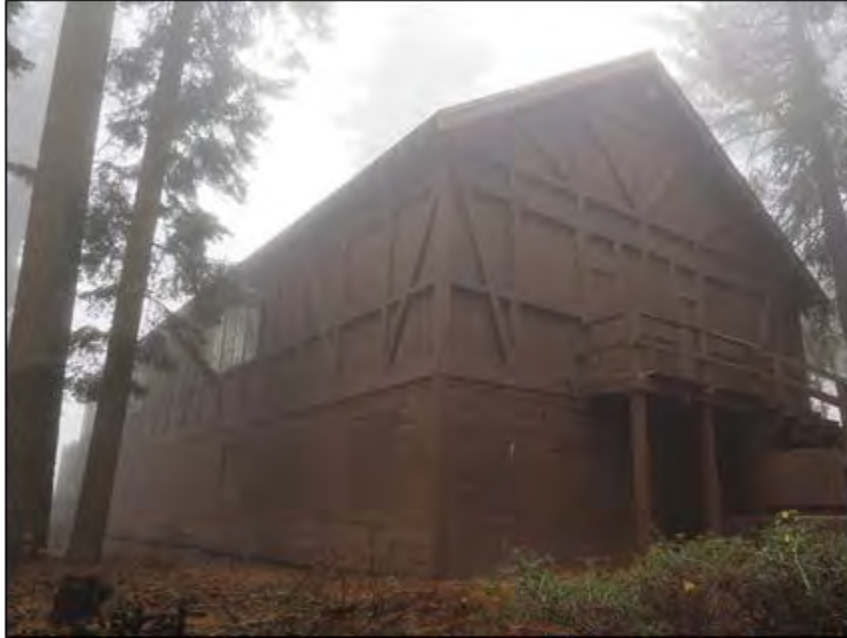
Observed fire activity near both the Giant Forest Ranger Residence and Beetle Rock Building is thought to be the results of a backburn closest to the development of the Giant Forest area. This backburn was completed to reduce the vegetation immediately in proximity to threatened resources. The effort to protect the Giant Forest Village/Camp Kaweah Historic District with a backburn was successful, as no buildings within the district show signs of either fire or suppression effects. Hazard trees could be in the area of both the Giant Forest Ranger Residence and Beetle Rock Building, either as a result of the backburn or wildfire.

*Photo 14 Beetle Rock Building (Assembly Hall). View looking west.*

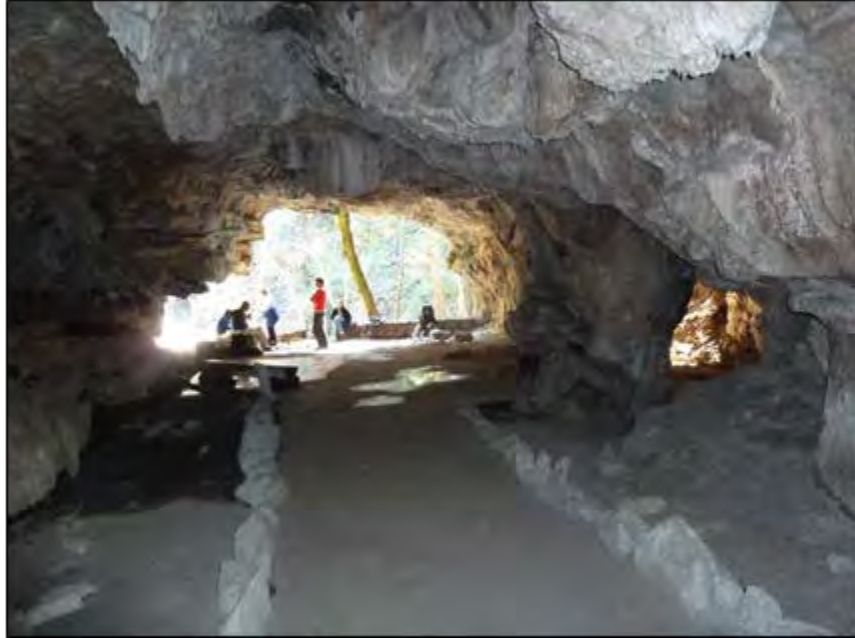
The Crystal Cave Historic District is located in the Crystal Cave area west of the Giant Forest Grove. A trail originally built by the CCC between 1938 and 1941 facilitates the popular tours offered by the park in summer. The period of significance is 1933 to 1965. The contributing features of the Crystal Cave Historic District include the Crystal Cave Road, the Crystal Cave Parking Area, Comfort Station, Access Trail, and Interior Trail. Because of fire conditions and the impassable road hazards, the BAER team was unable to confirm the condition of the Crystal Cave Historic District or make any further assessments.

*Photo 15 Crystal Cave Trail*
